Revised Draft WRIA 20 Inventory and Characterization Report (ICR)

Prepared by
Miranda Wecker and Rebekah Gentry
UW Olympic Natural Resources Center
June 30, 2011

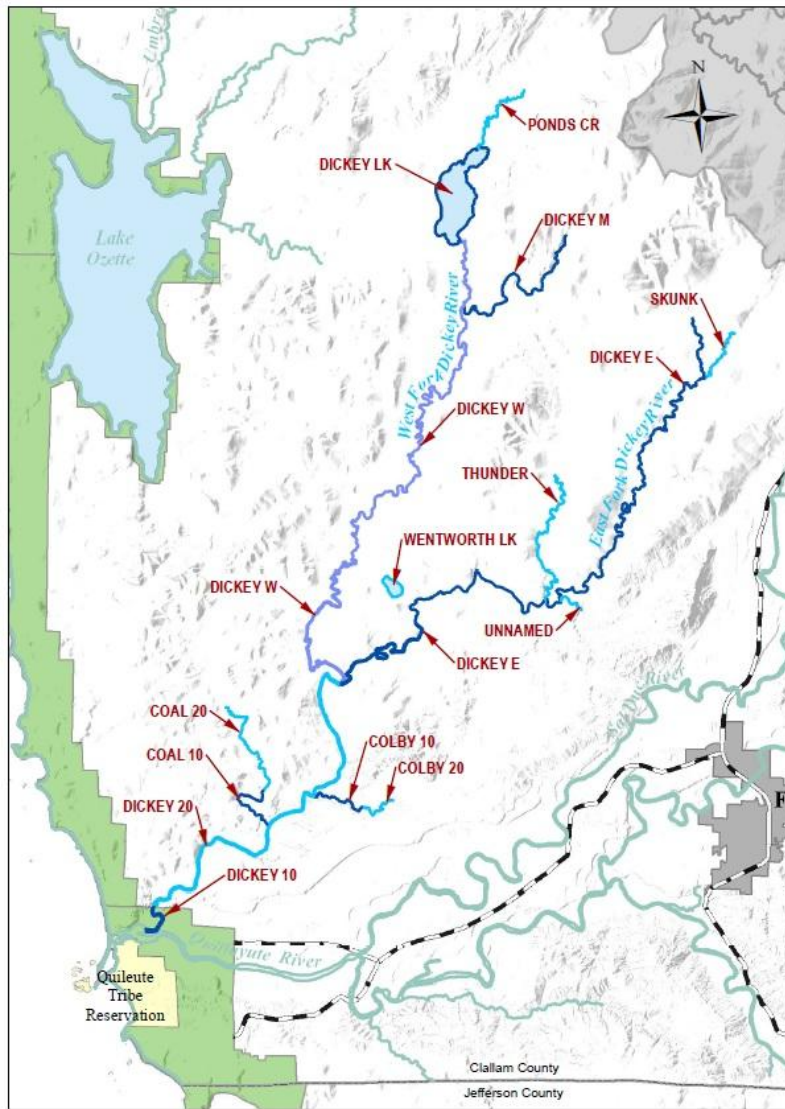
The Dickey River System

The Dickey River is a major tributary that drains into the Quillayute River about 1.5 miles from the Pacific Ocean. The Dickey Watershed extends from the mouth near sea level to ridge tops reaching 1,200 to 1,400 feet in elevation. Most of the subbasin is low elevation, lying below 440 feet. The Dickey basin contains the mainstem segments DICKEY 10-20 (8.7 miles long); three major tributaries: DICKEY E (16.5 miles), DICKEY W (14.9 miles) and DICKEY M (4 miles); several creeks: COAL 10 (1.4 miles), COAL 20 (2.5 miles), COLBY (1.2 miles), POND CR (2 miles), SKUNK (1.3 miles) and THUNDER (3.5 miles); and the two lakes: WENTWORTH LAKE and DICKY LAKE (520 acres). An estimated 830 acres of wetland areas occur within the subbasin, most of which are concentrated in DICKEY W. An unnamed tributary that meets the definition of shoreline of statewide significance flows into DICKEY E.
